## TECHNICAL SERVICE BULLETIN

### Soft Top Wear Above B-Pillar

22-  
2274

Ford  
2021-2022 Bronco

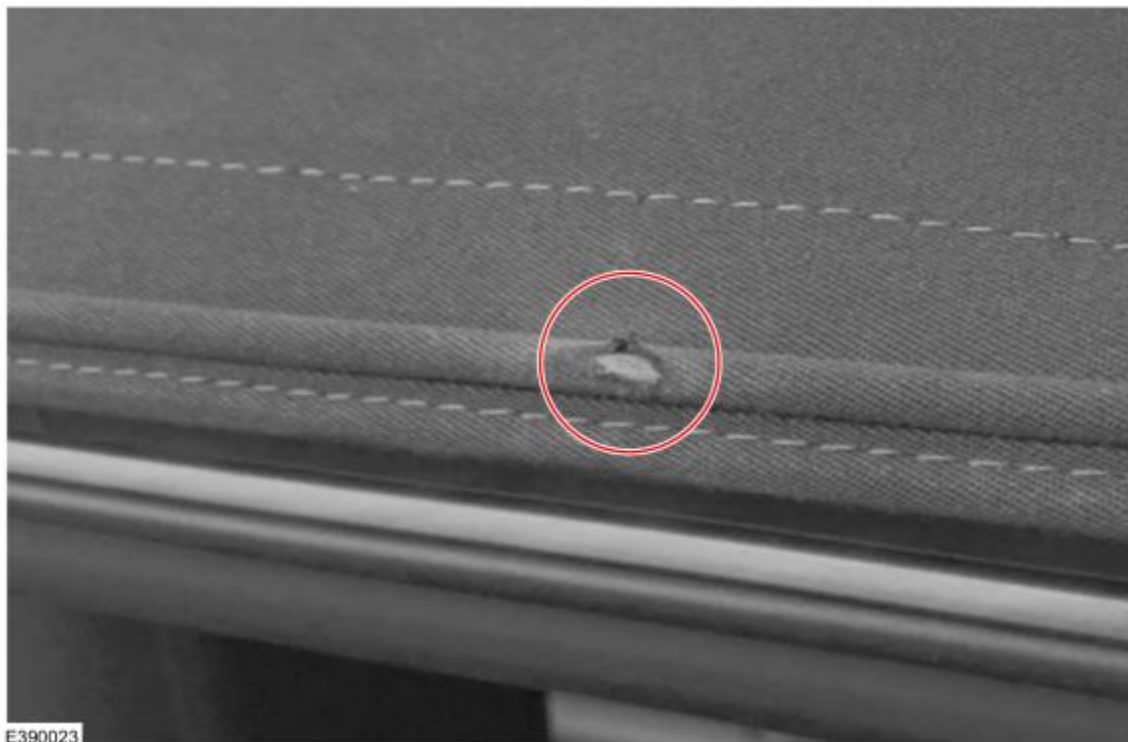
Figure 1

**Issue:** Some 2021-2022 Bronco vehicles equipped with a soft top may exhibit exterior wear on the sides of the top above the B-pillar. This may be due to contact and rubbing between the soft top frame and fabric. To correct the condition, follow the Service Procedure to replace both right and left deflectors attached to the soft top frame and soft top cover.

1. Does the soft top exhibit wear above the B-pillar similar to Figure 1?

(1). Yes - proceed to Step 2. Updated deflectors will be installed on both sides of the soft top frame assembly to prevent wear.
