# TECHNICAL SERVICE BULLETIN

## 5 Door - Hard Top Roof - Squeak And/Or Chirp From Rear Of Vehicle

22-2097

<b>Ford</b>	5 door
2021-2022 Bronco	Hard top roof

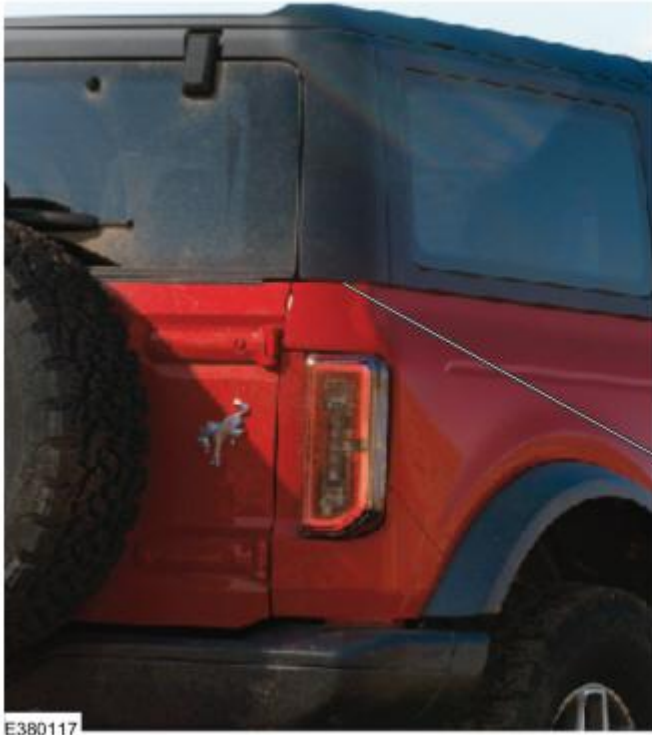
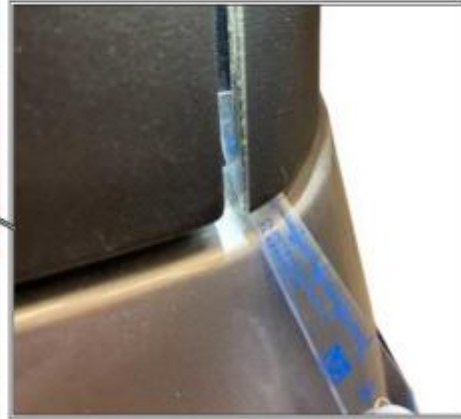
Figure 1

**Issue:** Some 2021-2022 Bronco vehicles equipped with 5 doors and a hard top roof may experience a squeak and/or chirp noise from the rear of the vehicle while driving over bumps with the roof installed. This may be due to an insufficient gap between the hard top and the body rear quarter panel. To correct the condition, follow the Service Procedure to adjust this gap to the correct specifications.

1. Insert a 3/64 in. (1 mm) plastic feeler gauge in the gap between the bottom/rear corner of the hard top and the rear quarter panel until the gauge is 2 in. (50 mm) deep. (Figure 1)

- 10.** Use a plastic feeler gauge to measure the gap between the bottom/rear corner of the hard top and the rear quarter panel. (Figure 1)
- 11.** Does the gap measure between 3/32 - 7/32 in (2.5 - 5.5 mm)?

- 14.** Use a plastic feeler gauge to measure the gap between the bottom/rear corner of the hard top and the rear quarter panel. (Figure 1)
- 15.** Does the gap measure between 3/32 - 7/32 in (2.5 - 5.5 mm)?
