## TECHNICAL SERVICE BULLETIN

### Water Leak From A-Pillars And/Or Windshield Header

**21-2403**

| <b>Ford</b><br>2021 Bronco |

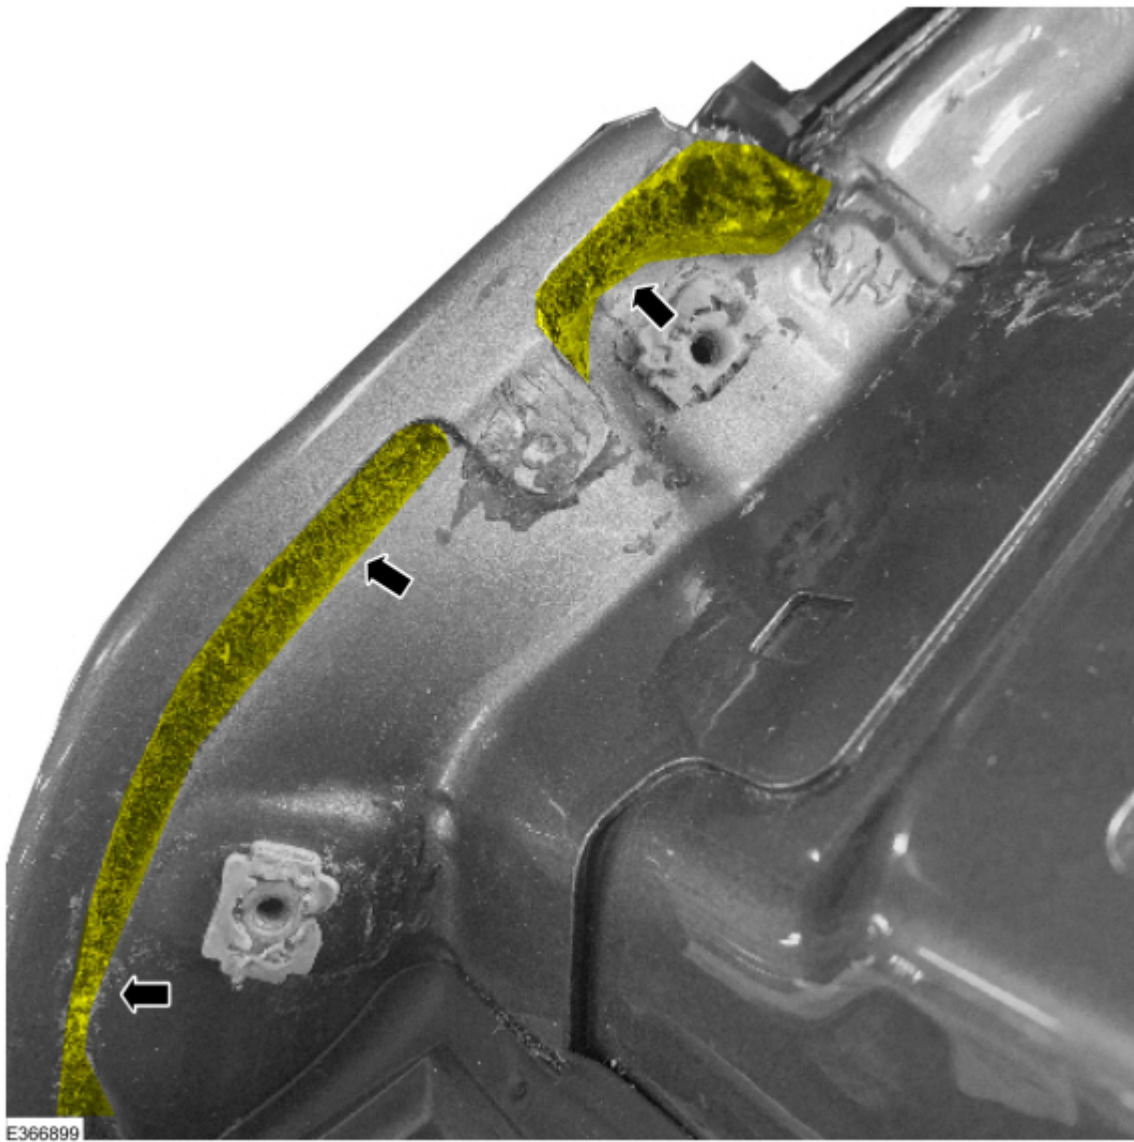
Figure 5

**Issue:** Some 2021 Bronco vehicles may experience a water leak that originates from the left and/or right A-Pillars and/or the windshield header. This may be due to excessive gaps in the body seams from the factory. To correct the condition, follow the Service Procedure to reseal the affected body gaps and replace the front header seal.

5. Clean the header seal mating surface on the body by removing all residual sealer left over from the old header seal. Use a plastic scraper and isopropyl alcohol wipes to clean the surface without harming the painted surface. If any painted surfaces are scratched during the cleaning process, touch up these areas with paint (covering any exposed metal) prior to proceeding.
6. Follow the instructions on the container to apply 3M™ Strip-Calk to the exposed body seams starting at the roof rack trim cover area and ending at the corner seal where the body seam ends. Do not leave a gap between the edge of the caulk and the corner seal. (Figures 5-8)
