## CERTAIN 2026 MODEL YEAR BRONCO RAPTOR — ENGINE COMPARTMENT WIRE HARNESS REPAIR

### SERVICE PROCEDURE

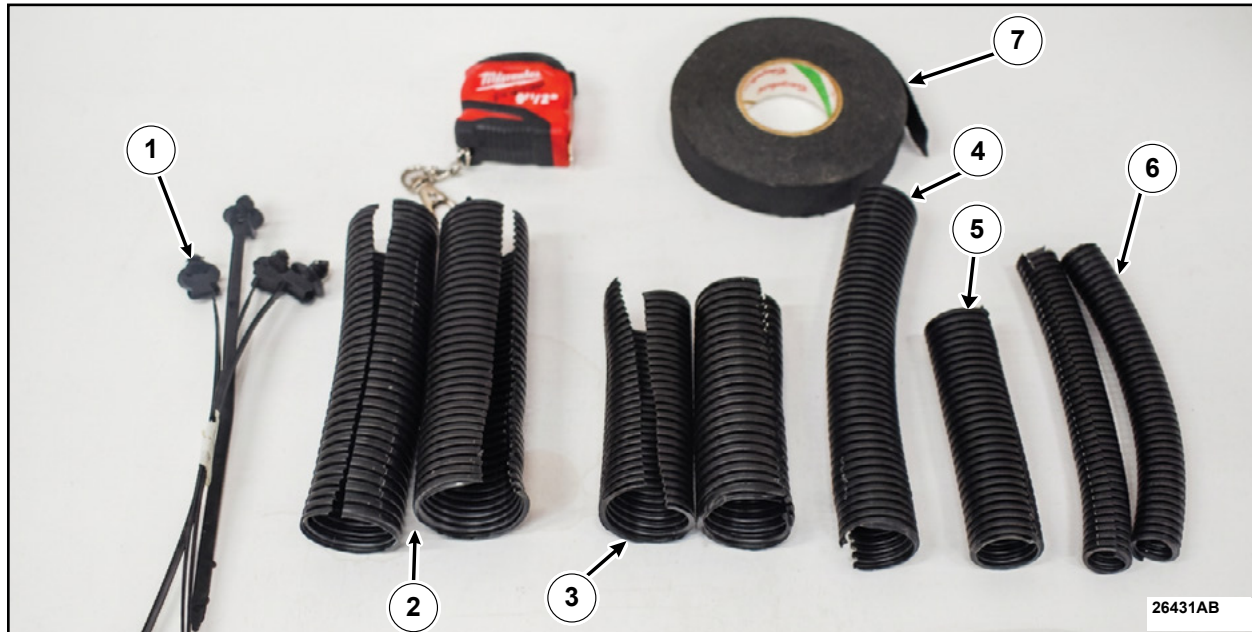
**FIGURE 1**

1. Using a cutting tool, cut the convolute tube into sections. Refer to the Parts Table on Page 1, and See Figure 1.

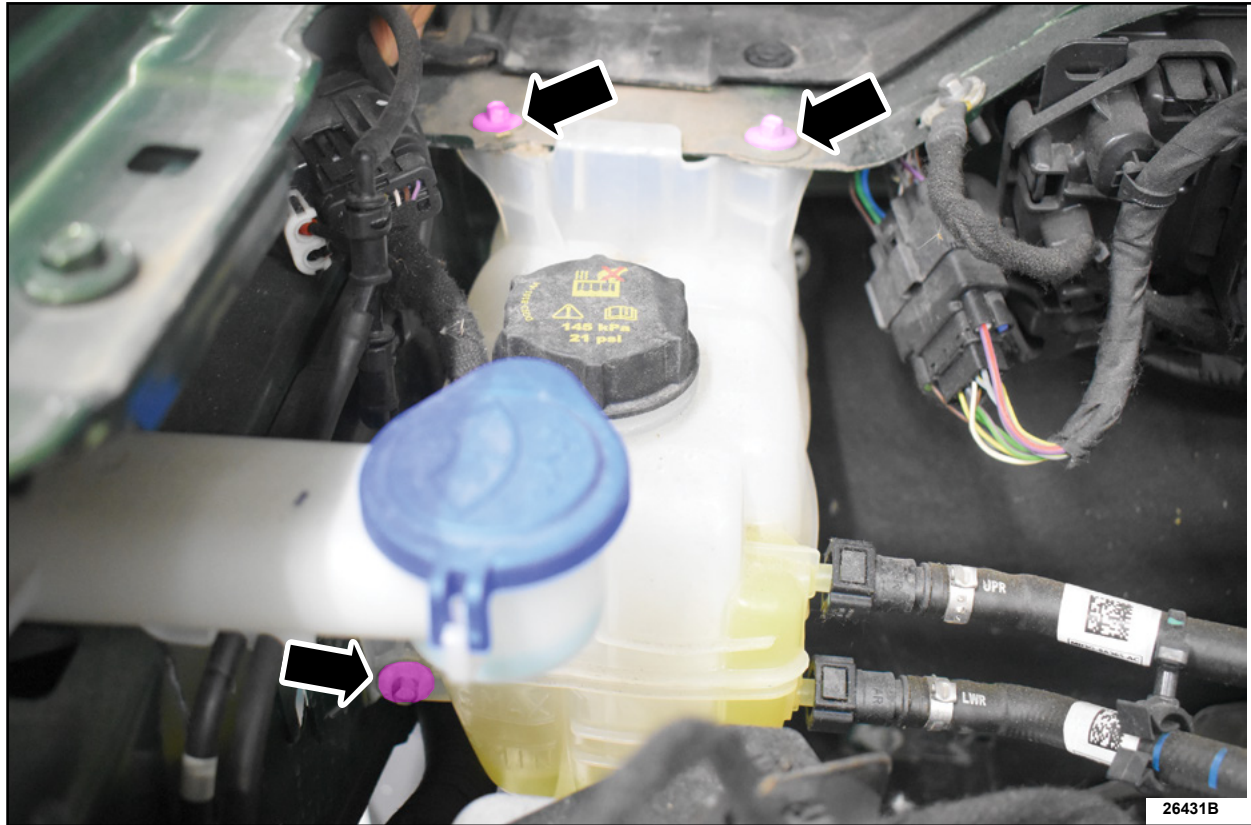
FIGURE 2

2. Remove the fasteners and position the degas bottle aside. See Figure 2.

- Torque: 44 lb.in (5 Nm)

**NOTE:** Do not disconnect the coolant tubes.

22. Install the degas bottle by reversing the procedures in Step 2. See Figure 2.

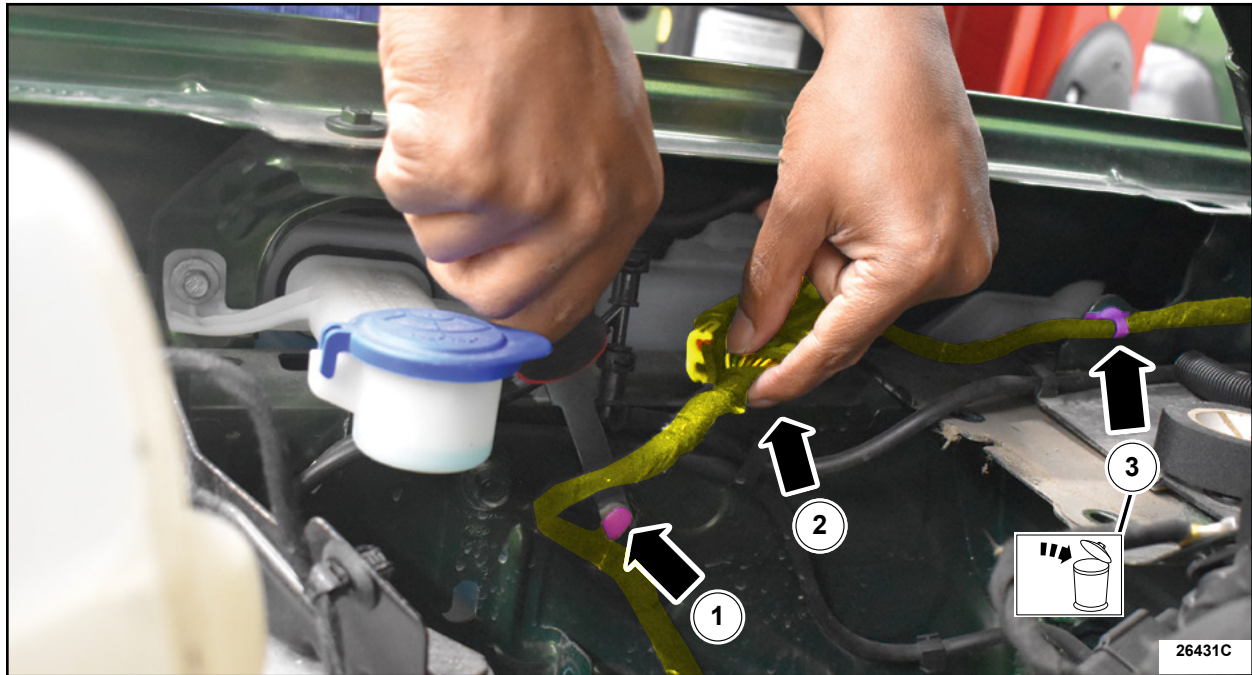
**FIGURE 3**

3. Disconnect the three retainers on the wire harness. Discard retainer (3). See Figure 3.

- (1) - Retainer
- (2) - Retainer is located under the wire harness pigtail.
- (3) - Retainer is one time use.

5. Starting at retainer (1), inspect the harness for broken wires or signs of chafing. See Figures 3 and 4.
